RUSSELLTON SLURRY POND 3

REPUBLIC STEEL CORPORATION

PHASE I INSPECTION REPORT
NATIONAL DAM INSPECTION PROGRAM

RUSSELLTON SLURRY POND 3
ALLEGHENY COUNTY, COMMONWEALTH OF PENNSYLVANIA
NDI NO. PA 00839
PennDER NO. 2-52

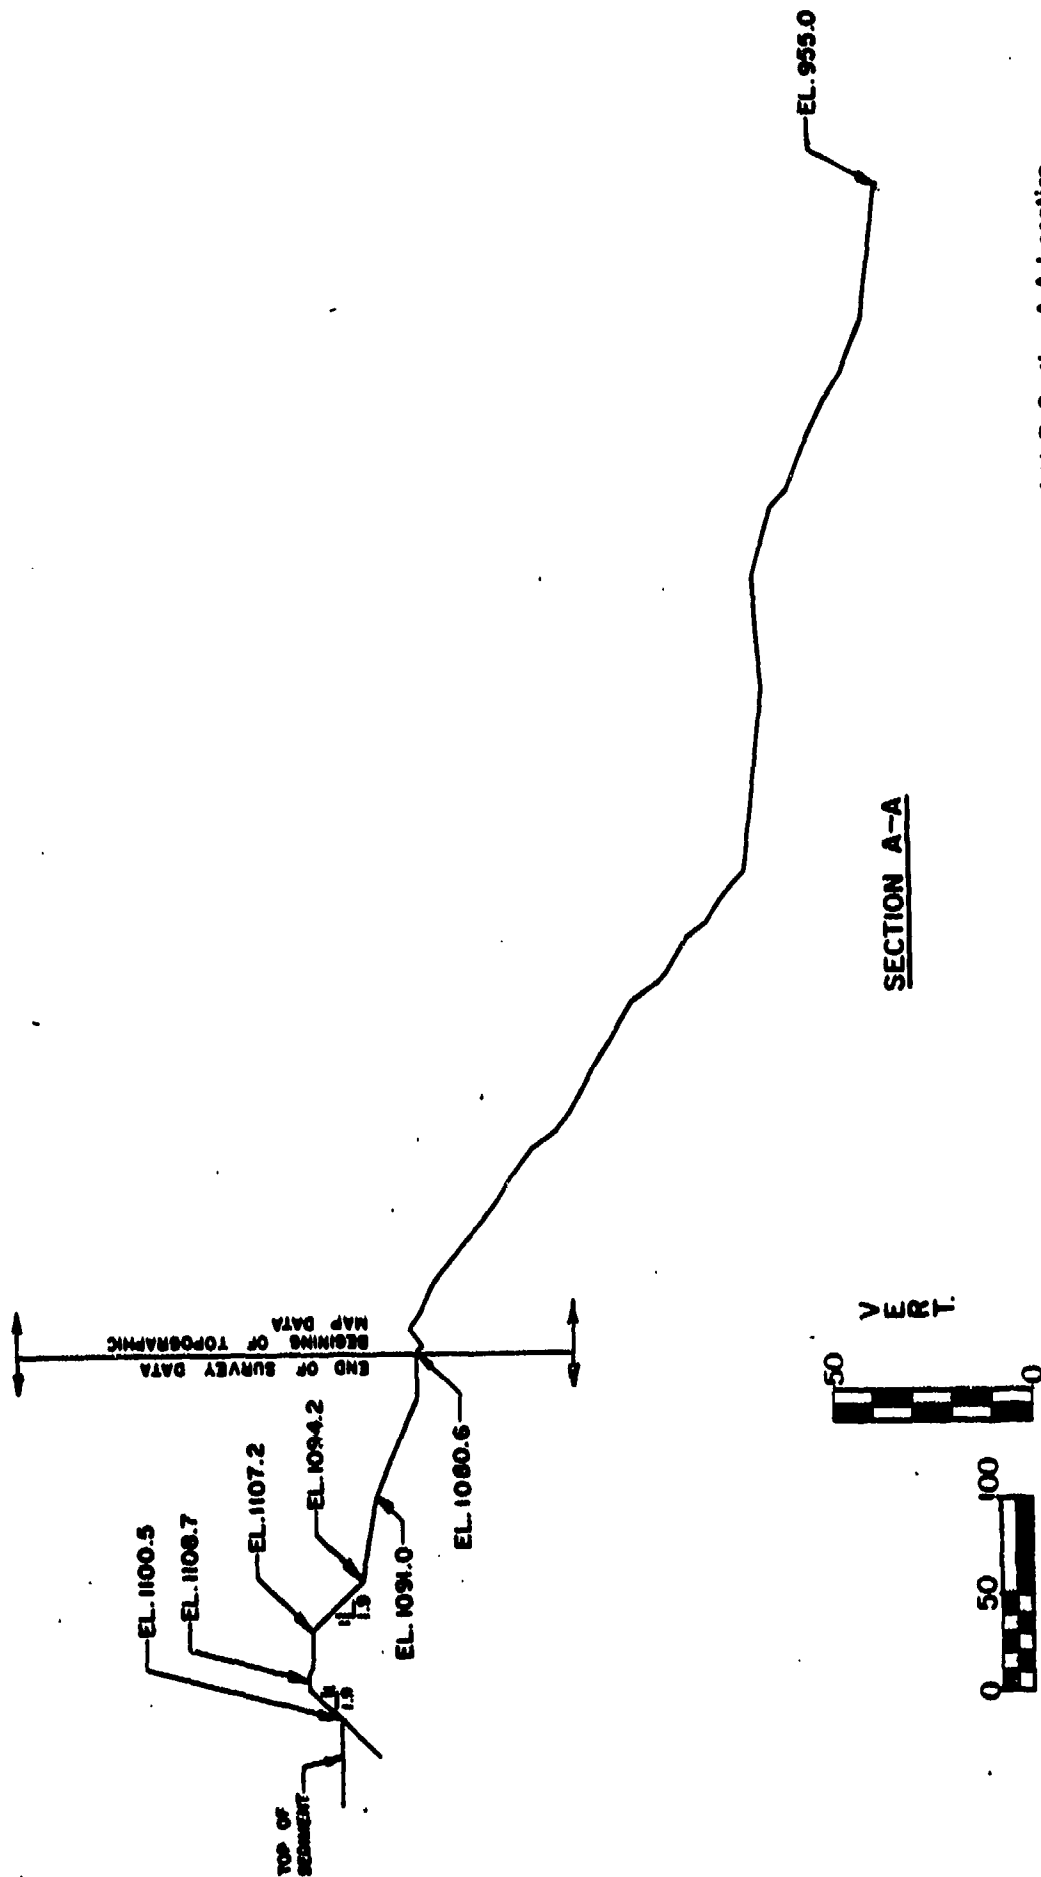
DATE: JULY 1981	RUSSELLTON SLURRY POND 3		FIELD SECTION
SCALE: AS SHOWN	NATIONAL DAM INSPECTION PROGRAM		
DR: JF	CK: JEB	ACKENHEIL & ASSOCIATES CONSULTING ENGINEERS	
DWG. NO. 8038 L - 3		GEO SYSTEMS, INC. 1000 BANKSVILLE RD./PITTSBURGH, PA. 15216

d. Visual Observations: The visual inspection disclosed that locally very steep slopes exist on the downstream face of the embankment, but little or no sloughing or slope instability was observed. There were no signs of cracks, scars, or anomalous bulges. The overall embankment slope is generally moderate to mild, as indicated by Field Section A-.
